DEPARTMENT OF TRANSPORTATION**DIVISION OF ENGINEERING SERVICES**

Quality Assurance and Source Inspection

Contract #: 04-0120F4Cty: SF/ALA Rte: 80 PM: 13.2/13.9File #: 69.28**WELDING INSPECTION REPORT****Resident Engineer:**Pursell, Gary**Address:** 333 Burma Road**City:** Oakland, CA 94607**Report No:** WIR-006949**Date Inspected:** 28-May-2009**Project Name:** SAS Superstructure**OSM Arrival Time:** 700**Prime Contractor:** American Bridge/Fluor Enterprises, a JV**OSM Departure Time:** 1900**Contractor:** Zhenhua Port Machinery Company, Ltd (ZPMC), Changxing Island **Location:** Shanghai, China**CWI Name:** Chen Chih Chien**CWI Present:** Yes No**Inspected CWI report:** Yes No N/A**Rod Oven in Use:** Yes No N/A**Electrode to specification:** Yes No N/A**Weld Procedures Followed:** Yes No N/A**Qualified Welders:** Yes No N/A**Verified Joint Fit-up:** Yes No N/A**Approved Drawings:** Yes No N/A**Approved WPS:** Yes No N/A**Delayed / Cancelled:** Yes No N/A**Bridge No:** 34-0006**Component:** OBG crossbeams**Summary of Items Observed:**

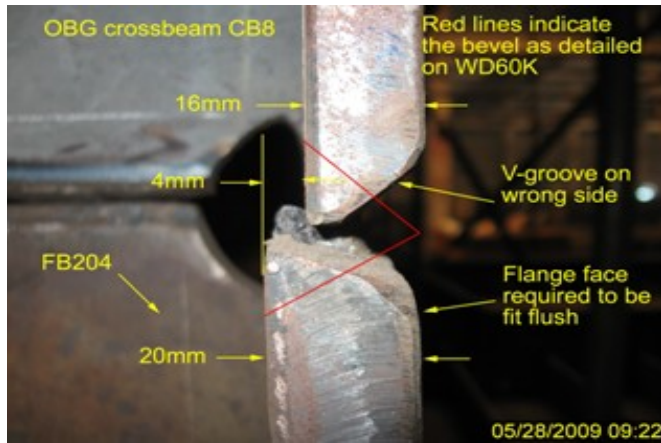
During random joint fit up inspection this QA observed two floorbeam diaphragm Complete Joint Penetration (CJP) weld joints that appeared to be misaligned beyond the tolerances of AWS D1.5 2002 section 3.3.3 which states parts to be joined by groove welds shall not be misaligned by more than 10% of the thickness of the thinner part or a maximum of 3mm. The joints in question appeared to be misaligned 5mm and 6mm. See attached photo

for details. The weld joints are identified as FB204-070 (2nd floorbeam from the north end) and FB205-032 (2nd floorbeam from the north end). This QA also observed two excessive root openings. One of the joints is a fillet weld joint identified as CB202G-155 and 156 (4th floorbeam from the north end). The root opening measured from 6mm to 10mm. The other joint is a CJP identified as FB205-029 (1st floorbeam from the north end). The root opening measured 10mm to 11mm. This QA informed ZPMC QC CWI identified as Mr. Chen Chih Chien and ABF QA inspector identified as Mr. Peng Wen Jun of these issues. Mr. Chen and Mr. Peng informed this QA that the misaligned joints would be corrected prior to welding, the excessive root opening on the CJP would be buttered (build up by welding) prior to welding the joint and the excessive fillet weld root opening would be changed to a CJP weld per approved submittal# 200, Rev. 2 dated Feb. 12, 2009. The proposed resolutions to these misalignment and root opening issues appear to be within the general scope of the contract documents and no incident report will be generated provided the contractor follows through with the proposed resolutions as outlined above.
